Technical Report

An Investigation into the Effect of Near Bottom Currents on the Structural Stability of Enbridge
Line 5 in the Straits of Mackinac

Edward E. Timm, PhD, PE
5785 Deer Run Trail
Harbor Springs, MI 49740
231-526-7159 EdTimm@Gmail.com

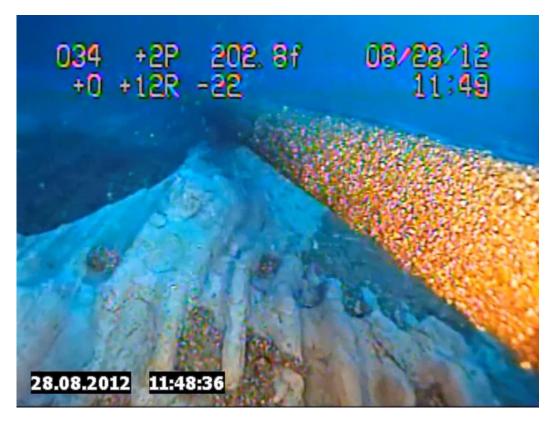
Enbridge Line 5 mostly rests on the lake bottom. However, as explained in Appendix 1, several unsupported spans were left from the original construction or developed later due to bottom scouring or "washout". Figure 19 is a photograph taken from Enbridge's 2012 underwater inspection video that illustrates an unsupported span on the east leg near the south side of the ancient river bed that runs through the Straits. Although it is hard to exactly determine the distance from the pipe to the lake bottom it appears to be on the order of ten to fifteen feet. It also appears in this photo that the bottom is scoured clean of sediment since the marks left in the hardpan clay bottom by the teeth of the clamshell dredge used to level this area during construction in 1953 are still prominent.

Figure 19. Photo of Unsupported Span Clipped from Enbridge Underwater Inspection Video from the 2012 Inspection (East Leg, ~203 feet water depth)

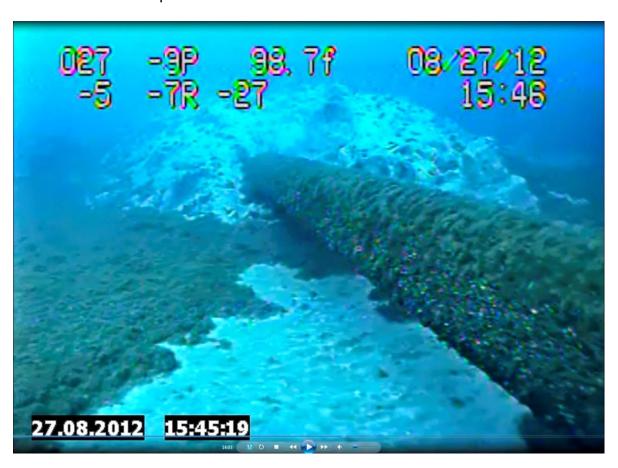
Figure 30. Frame Grab from Enbridge 2012 Underwater Inspection Video²⁴ of the East Leg of Line 5 under the Straits of Mackinac Depicting a Clay Pile

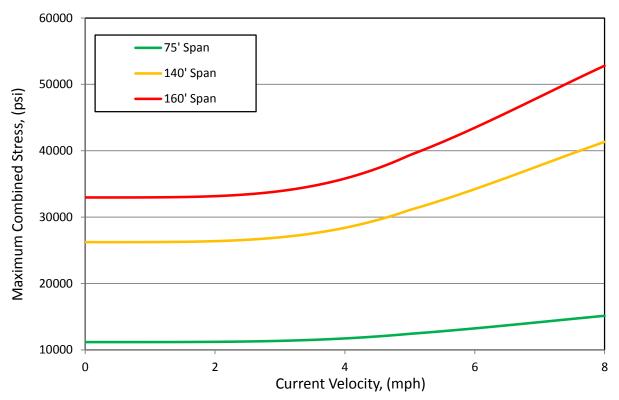
Figure 31 shows the maximum combined stress from pressure, gravitational and drag forces as a function of current velocity. Up to about the design specification current velocity (2.25 mph), the current has little effect on combined stress. X35 steel has a specification yield stress of 35,000 lb/in². At the easement specified minimum unsupported span of 75', the structure has a safety margin of ~three compared to the yield strength of the steel. At Salvadori's recommended maximum unsupported span of 140 the design is at 75% of the yield strength which is greater than the ASME B31.4 code requirement of 72% maximum. At the 160' unsupported span that is found on the 1964 as built blueprints and not fully corrected until 2001, the design is at 97% of yield. Referring to Figure 30, a current of 3.6 mph will push the

Figure 31. Maximum Combined Stress for Line 5 as a Function of Current Velocity

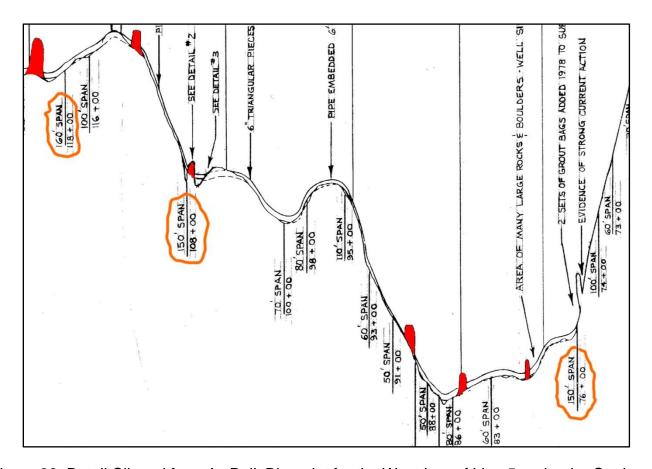
Figure 32. Detail Clipped from As Built Blueprint for the West Leg of Line 5 under the Straits as Referenced in Appendix 1 (Clay Piles Annotated in Orange)

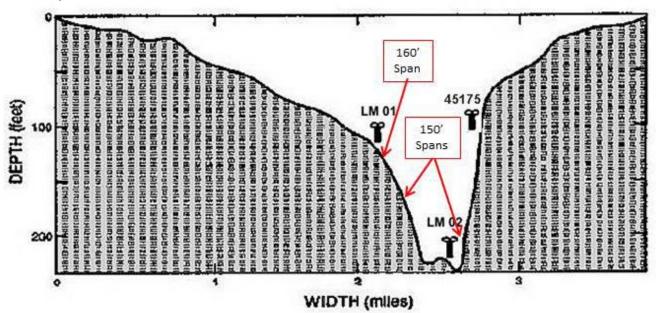
Figure 37. Cross Sectional View of the Straits of Mackinac Showing Locations of Long Unsupported Spans in Relation to Buoy Positions

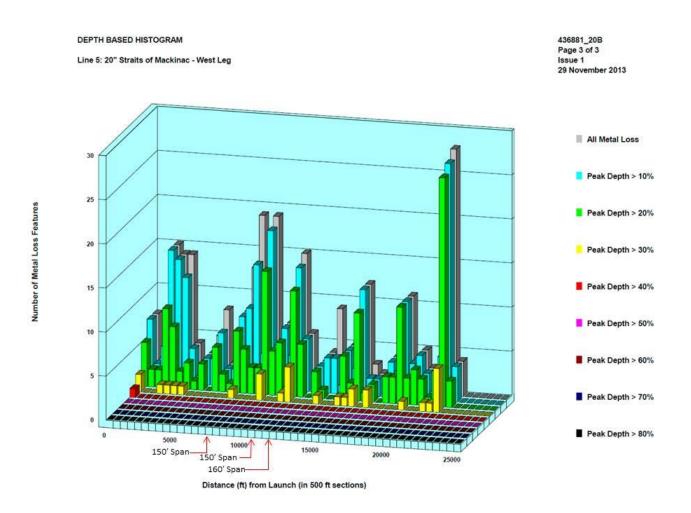
An additional concern regarding the condition of these long unsupported spans can be raised by Figure 38. A document²⁸ released by the Michigan Pipeline Task Force shows an annotated histogram of metal loss features in the west leg of Line 5 as measured during a 2013 MFL inspection scan. The locations of the long unsupported spans discussed in this report have been superimposed on this figure. Figure 38 groups the number of metal loss features into 500' long sections of the pipe and gives the metal loss depth histogram for each 500' section inspected. It can be seen from Figure 38 that each section that includes long unsupported spans also includes a number of metal loss features with depths ranging up to 30% of the pipe wall thickness. These metal loss features have been assigned by the ILI contractor as "mill defects" but, if any of these features are included in the unsupported spans discussed here, they could have a significant impact on the fatigue life of the welded structure. The resolution of Figure 38 is insufficient to draw a conclusion about this and the features are not located precisely due to differing chainage measurements between different contractors, but all the ILI data available should be examined at the highest resolution to look for any suggestion that fatigue cracking exists in these sections.

Figure 38. Annotated Histogram of Metal Loss Features in the West Leg of Line 5 from a 2013 MFL Inspection Report²⁸.

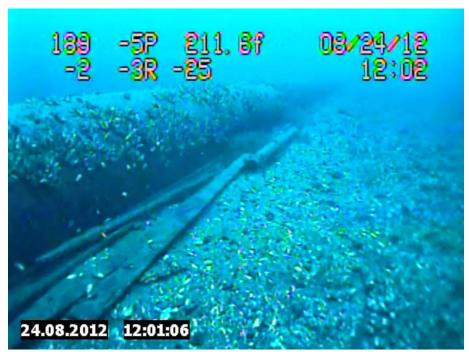
Figure 6. Photo Clipped from Enbridge 2012 Underwater Inspection Video of the West Line Taken on 8/24/2012 at 12:01:06 Showing Detached Slats.

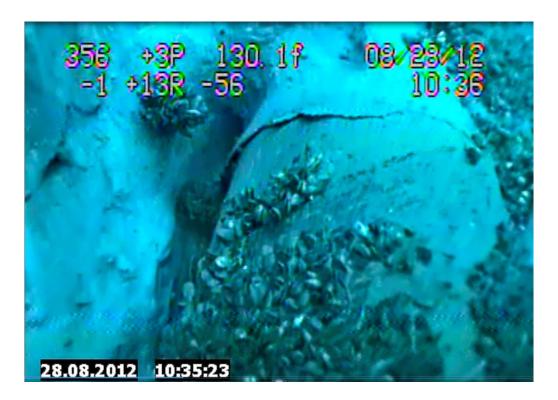
Figure 7. Photo Clipped from Enbridge 2012 Underwater Inspection Video of the East Line Taken on 8/28/2012 at 10:35:23 Showing Missing and Disbonded Coating

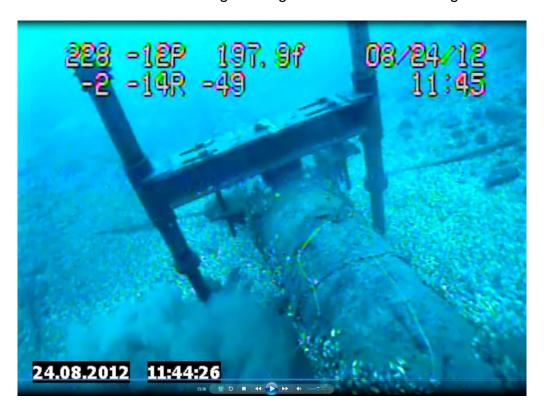
Figure 8. Photo Clipped from Enbridge 2012 Underwater Inspection Video of the East Line Taken on 8/24/2012 at 11:44:26 Showing Missing and Disbonded Coating

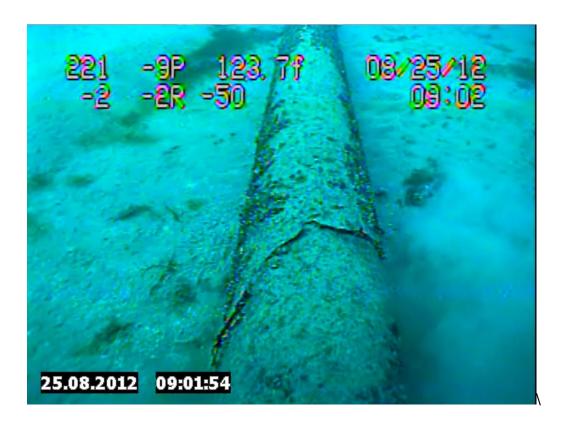
Figure 9. Photo Clipped from Enbridge 2012 Underwater Inspection Video of the East Line Taken on 8/25/2012 at 09:01:54 Showing Missing and Disbonded Coating

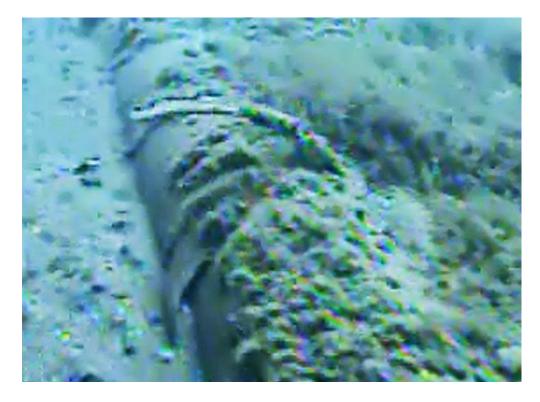
Figure 10. Detail from Photo Clipped from Enbridge 2012 Underwater Inspection Video of the West Line Taken on 8/25/2012 at 15:58:44 Showing Disbonded Coating and Broken Band

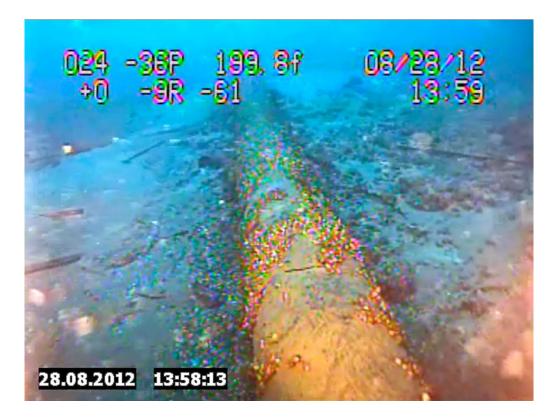
Figure 11. True Color Photo Clipped from Enbridge 2012 Underwater Inspection Video of the East Line Taken on 8/28/2012 at 13:58:13 Showing Missing and Disbonded Coating and Rusty Coloration of Pipe with Apparent Pitting Corrosion

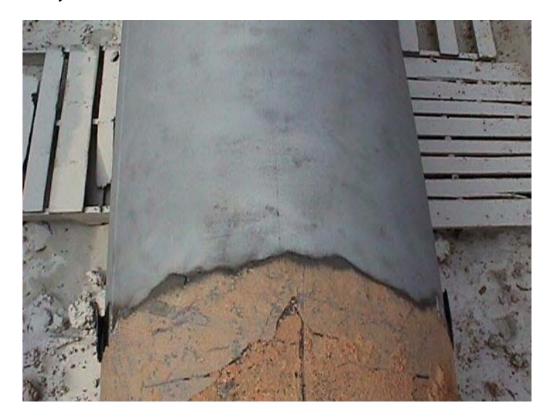
Figure 12. Typical Corrosion Found Under a Disbonded Coating as Reveled by Light Abrasive Blasting
