Technical Report

An Investigation into the Effect of Near Bottom Currents on the Structural Stability of Enbridge
Line 5 in the Straits of Mackinac

Edward E. Timm, PhD, PE
5785 Deer Run Trail
Harbor Springs, MI 49740
231-526-7159 EdTimm@Gmail.com

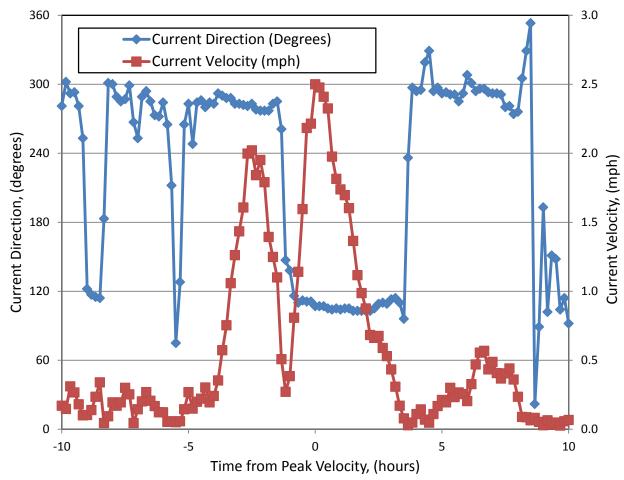
before and after a peak current event. The current goes from a negligible velocity to a peak velocity of 2.0 mph towards the west in about 2.5 hours then drops to a negligible velocity and reaches a peak velocity of 2.5 mph towards the east in a subsequent 2.5 hour period before dropping to a negligible value in another three hours. Such a violent reversal of flow in such a large waterway is unprecedented in the author's experience and certainly has implication for the structural stability of this largely unsupported (except by erodible soil) pipeline.

Figure 9. Current Velocity and Direction during a Peak Velocity Event for Buoy Data Set LM 02, Bin 1

Figure 9, showing data from buoy data set LM 02, shows an event where the current goes from slack water, to a maximum of 2 mph towards the east, to slack water, to a maximum of 2.5 mph towards the west and back to slack water in an eight hour period. Events like this offer the possibility of yielding the pipe in one direction then, shortly later, yielding the pipe in the opposite direction. Figure 31 shows the maximum combined stress for line 5 based on a

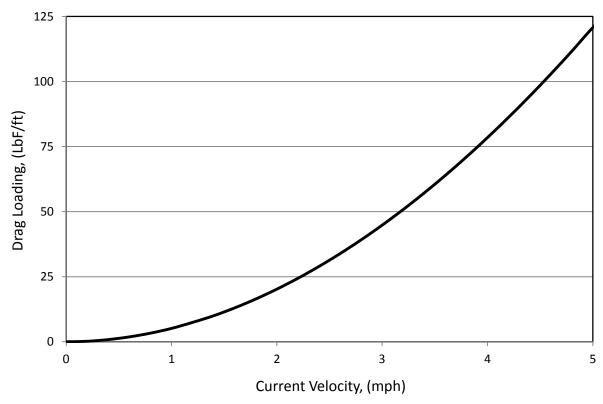
Figure 18. Drag Force on a Circular Cylinder with a 22 inch Diameter and a Surface Roughness of 30*10⁻³ at 10⁰ C Water Temperature

Figure 17 applies to a cylinder in a free stream. Line 5 exists in a condition where it may be resting on the bottom or where an unsupported span may be many pipe diameters from the bottom. When the pipe is resting on the bottom, the flow around the pipe is stagnated and the drag force on the pipe results in a rolling moment on the pipe which induces a resisting torque. This situation was analyzed by Salvadori for velocities up to 2.25 mph and was found not problematic. Once the pipe is off the bottom, flow around the pipe results in a bending moment which must be considered together with the forces from internal pressure and gravity. Yang, Jeng, Gao and Wu¹⁹ have analyzed the scenario where the pipe is supported at various distances from the lake bottom and found that if the pipe is further than about 80% of the pipe diameter from the bottom it acts as if it is in a free stream. The drag force values in Figure 18 are valid as long as this condition is met. When the pipe is closer to the lake bottom than 80% of the pipe diameter, the situation becomes complex and the drag forces may be either greater or lesser than those computed for Figure 18.

The drag forces shown in Figure 18 are almost instantaneous in their response to changes in current velocity. This, along with the facts that ADCP cannot measure the current within about two meters from the bottom and the velocities determined in the previous section of this report are long term averages and not instantaneous measurements, complicates using Figure 18 in a straightforward stress analysis to determine if structural limits are being approached. As a

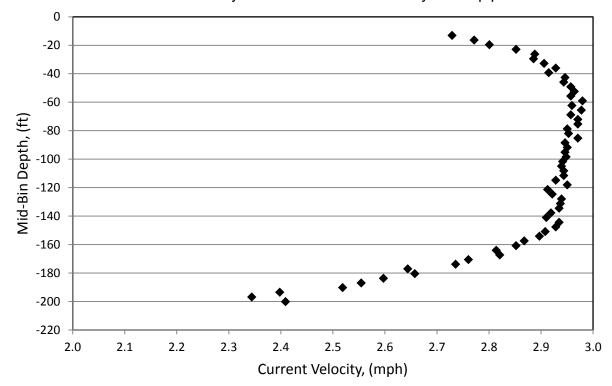
Figure 20 is the velocity profile taken from buoy data set LM 02 during a peak current event. This velocity profile is a long term average as previously discussed and it shows the velocity at the lowest bin to be about 89% of the maximum velocities found at mid-depth. Since the lowest bin data is typically somewhat above the location of the pipe, a question remains regarding what the actual instantaneous velocity is in the immediate vicinity of the pipe.

Figure 20. Velocity Profile Taken from Buoy Data Set LM 02 at the Time of a Peak Current Event.

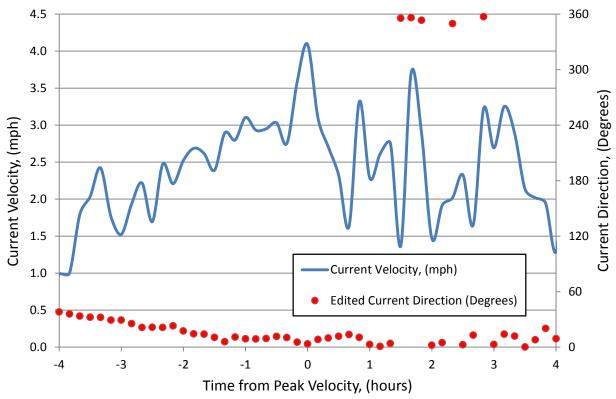
Figure 21 shows the correlation of current direction and current velocity during a peak current event for buoy data set 45175. The ten minute average data shows a peak current of over four mph moving towards the north. This direction is nearly perpendicular to the axis of the Straits of Mackinac and generally along the axis of Line 5. That this event lasts for about ten hours argues for the existence of a large scale, persistent mesoturbulent eddy.

Figure 21. Correlation of Current Velocity and Current Direction During a Peak Current Event for Buoy Data Set 45175

Table 13 shows the amount of time that the current velocity is estimated to be greater than 3.6 mph, the condition where a 160 foot unsupported span will reach the yield stress of X35 steel. Reference to Figure 21 shows that peak current events of significant magnitude typically last for about 20-30 minutes. Using the value of 30 minutes per peak current event results in the number of possible fatigue cycles due to bulk flow during extreme current events at three buoy locations for a 160 foot unsupported span. Based on this assumption, it is likely that the 160' unsupported span located at Bechtel Station 11800 has been subjected to between 200 and 300 reversing bending cycles over the 48 year period it was out of compliance with easement conditions and Salvadori's calculations.

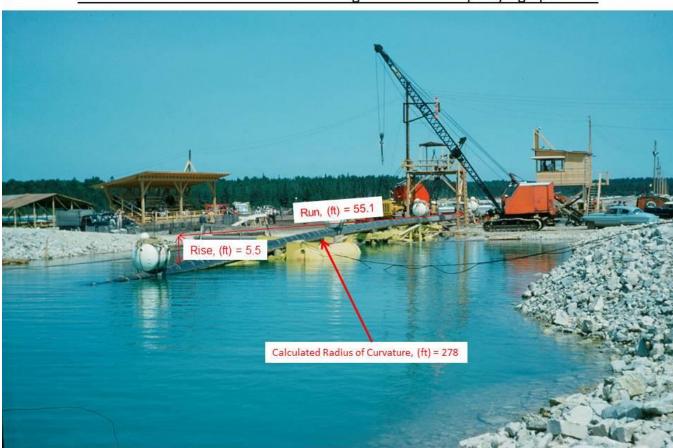
Figure 28. Estimation of Radius of Curvature During the Pipe Laying Operation in 1953 Figure 28. Estimation of Radius of Curvature During the Pipe Laying Operation in 1953

- 2. One specification set forth the in the easement was that "The minimum curvature of any section of pipe shall be no less than two thousand and fifty (2,050) foot radius." This specification was stricter that the one recommended by Salvadori in his engineering analysis where he recommended a minimum radius of curvature of 1750 feet. Calculation shows that the outer fiber of the pipe will reach yield at a radius of 690 feet. Both of these specifications were intended to prevent the welded pipe strings from being bent to a radius that would cause yielding and the accumulation of fatigue cycles during the pipe laying process. Figure 28 uses a photograph taken by Bruce Trudgen in 1953 that shows the pipe being pulled from the St. Ignace shoreline during the launching process. By carefully scaling the photo, it is clear that the pipe was yielded during launch by bending to a radius of curvature of ~300 feet. More importantly, as Trudgen mentions in his Spartan Engineer²³ article, the 2500 foot welded pipe

strings were moved around in the marshalling yard without respect to the 1750 foot radius limit. During a personal discussion with the author he mentioned that the operation where the pipe strings were moved onto the launch way by running a "shoe" suspended from a crane down the length of the string "bent the hell out of the pipe." A black and white photograph of this operation is shown as Figure 29. Additional discussion focused on problems with the pipe pulling operation where the pipe strings were pulled across the Straits in 2500 foot increments as they were welded revealed other opportunities for yielding. It is also clear from the as-built blueprints discussed in Appendix 1 that the bed prepared for the pipeline had significant discontinuities causing the pipe to be yielded into place in several locations. In some areas clay fill was used to fill these discontinuities and some of it appears to have been placed after the pipe was yielded into place in order to meet easement support requirements. Figure 30 is an example of one of these clay piles taken from Enbridge's 2012 underwater inspection video and it does not appear as if the clay piled on top of the pipe was placed after the clay under the pipe. What actually went on regarding the fifteen clay piles placed under the west leg of the pipe and the seven clay piles placed under the east leg of the pipe is lost to history and adds uncertainty about the yielding history in the segments of the pipe supported by these clay piles. It does appear as if several of these clay piles violate restriction (13) in the easement: "(13) In locations where fill is used, the top of the fill shall be no less than fifty (50) feet wide".

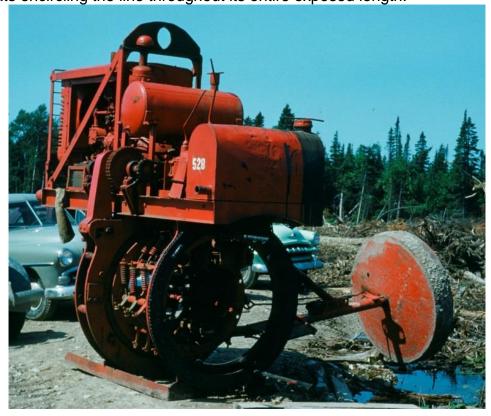
Figure 1. Trudgen Photo of Pipe Cleaning Machine (00010370013.tif)

A series of color photographs taken by Bruce Trudgen, a young MSU engineer who worked on the Line 5 project and wrote about it⁵ offer insight into the coating and wrapping system used on Line 5. Figure 1 shows the pipe cleaning machine which used a rotating brush assembly to clean the surface of the pipe and Figure 2 shows the pipe wrapping machine which was used to spiral wrap the pipe with reinforcing cloth.

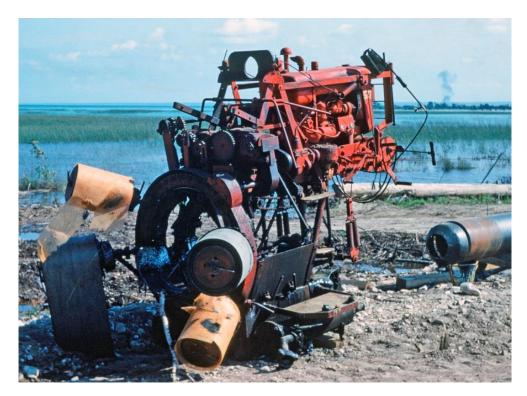
Figure 2. Trudgen Photo of Pipe Wrapping Machine (00010370012.tif)

Based on this document and Figure 2, which shows the pipe wrapping machine loaded with four rolls of similar, presumably asphalt saturated glass fiber fabric, it is probable that Line 5's coating system consists of a solvent based asphalt primer, two layers of asphalt saturated glass fiber fabric and a white protective overlayer of white craft paper bonded with asphalt enamel. The craft paper layer was intended to provide some abrasion protection to the underlayers and protect the wrapped pipe from the heat of the sun as described in reference 6. In addition to these layers, the pipe was intended to be wrapped with 1' x 4" wooden slats held on by encircling bands. A hint regarding the purpose of this wooden lagging can be found in Salvadori's report during a discussion of miscellaneous stresses on the pipe. It is believed that the purpose of these slats was to protect the coating from abrasion due to scrubbing on the lake bottom and to protect the pipe from point loading.

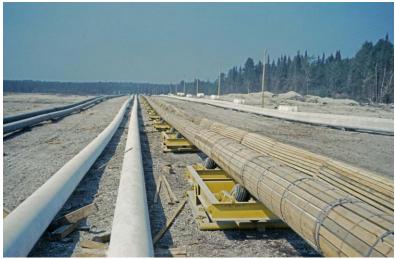
Figure 4. Trudgen Photo of Pipe Stockyard (00010370011.tif)

Figure 3 is a detail clipped from Figure 2 that shows the end of the cleaned and wrapped pipe and Figure 4 shows the assembled, coated pipe strings including one on the launchway prior to pulling them across the Straits. Figure 5 shows the welding operation that joined the 2500' strings together as the line was launched. Approximately eight such girth welds had to be made and coated in the 60-65 hour time it took to launch the pipes across the Straits. No details are available of how the pipe was preheated prior to welding or coated after welding in this operation where time was of the essence. It is notable that in Figure 5, the 1" x 4" wooden slats that were supposed to encircle the pipe are only covering the bottom third of the pipe as opposed to those pipes seen in Figure 4. According to Bruce Trudgen, this change was made to ease assembly of the pipe strings midway in the construction process. It is also apparent in Figure 5 that the presumed Kraft paper protective layer is only on the top third of the pipe. As in all construction projects, field changes to a design are inevitable, but no documentation has been discovered regarding field change procedures on the Line 5 project and their approval by engineering personnel.
